Maryland Historical Trust State Historic Sites Inventory Form

Survey No. S-324

historic Albert Sterling House

street & number 23 West Main Street not for publicationcity, town Crisfield vicinity ofcongressional district Firststate Marylandcounty Somerset

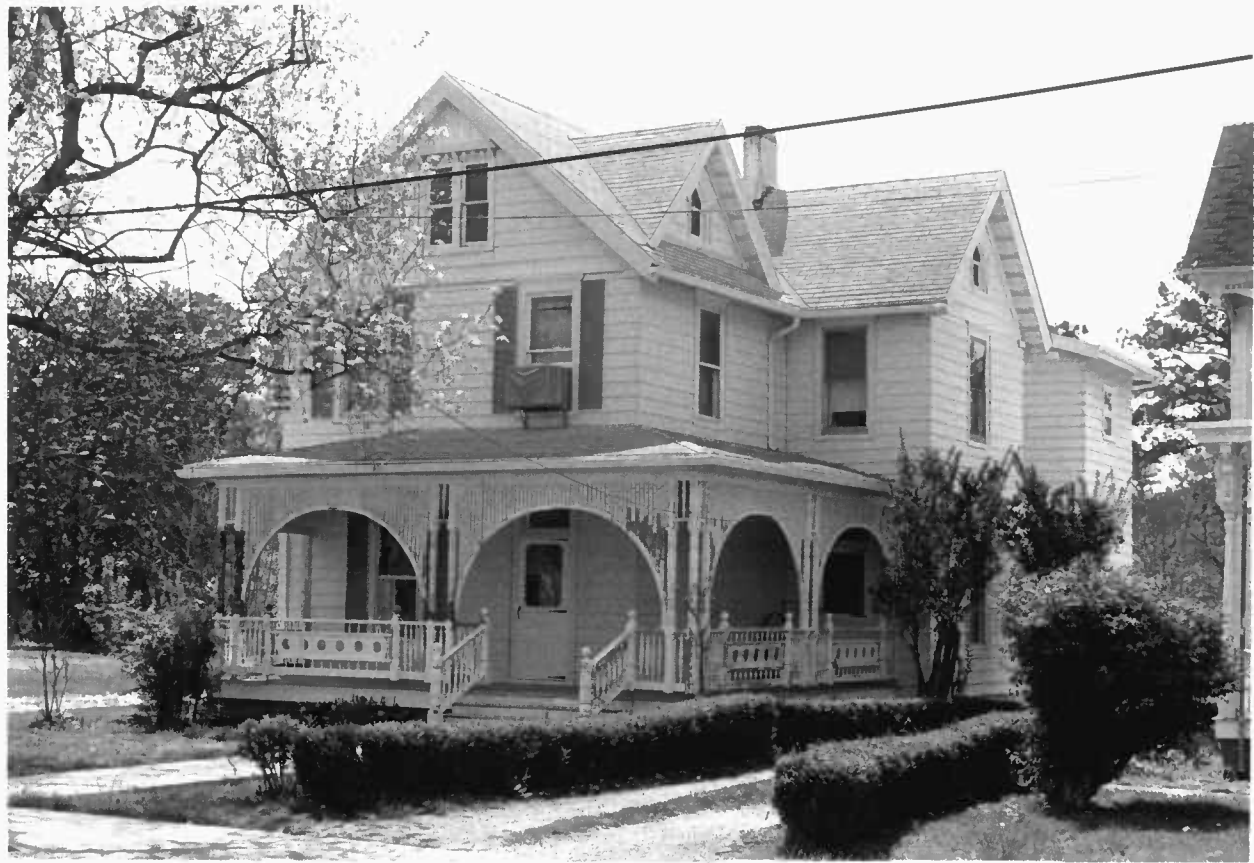
Albert Sterling House
Crisfield, Somerset County
North Elevation
7/85, Photographer, Paul Touart
Neg/Md. Historical Trust

The north (main) facade is an asymmetrical ell-shaped elevation with a two-bay principal facade and a single-bay recessed side entrance. The front of the house and the west side is covered by a rare Eastlake style porch supported by pairs of turned posts and distinguished by arched wood screens between each pair of posts. The porch railing is also intact and consists of turned posts, turned balusters and a molded handrail. Between the pairs of porch posts and under the arched screen is a rectangular wood panel with six round holes cut out. These decorative panels are located on the west side of the porch as well. Finally the porch step hand rails with turned posts and turned balusters are also intact. The two-bay main facade consists of a glazed and paneled door in the right (west) bay and an adjacent single-pane sash window with louvered aluminum shutters. The second floor is pierced by two single-pane sash windows, while the upper gable has a paired set of single-pane sash windows with a decorative bracketed hood. A recessed side door occupies the far right bay and is topped by a single-pane transom window. The second floor is pierced by a single-pane sash window.
